1. Background

The BoltHold chemical asphalt anchors provide a method to mount equipment and devices directly to asphalt roadways and similar asphalt surfaces. One of the most critical metrics for evaluating the suitability of an anchor for a particular application, is the anchor's ability to resist pull forces, thus keeping the load properly anchored to the surface.

This report provides a description of the test method used, and typical test results, to arrive at a pull rating for the anchors.

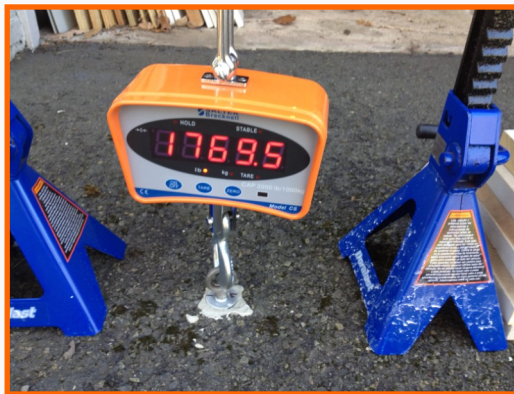
chors. In the case of the BoltHold chemical anchors, the bond between the anchor and the asphalt is as strong as the asphalt itself. As a result, when the pull force exceeds the strength of the asphalt, the asphalt starts to crown -- a small hill starts to rise concentrically with the anchor. As the force increases, the diameter of the hill increases, as well as its height. Failure is determined when the height of the crown reaches 1/2" above asphalt 6" away, (assuming that the surface is flat for a radius of 9" around the anchor).

The test involves pulling on an installed anchor vertically until (1) it rises a certain amount above the immediate surroundings, or (2) until a certain deformation in the asphalt takes place, whatever comes first.

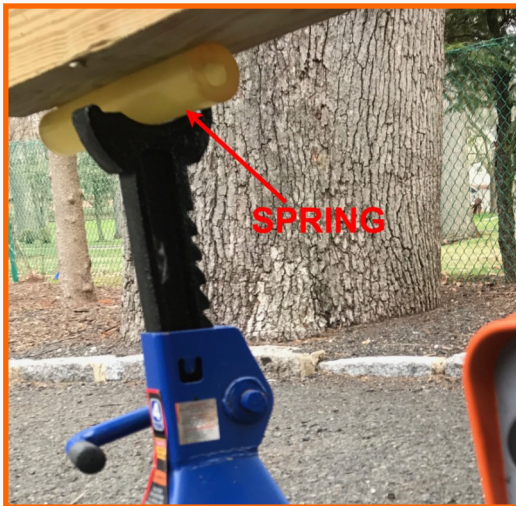
A force gage was attached to the anchor on one end, and to a cantilevered beam on the other. The beam rests on an hydraulic jack. As the jack is raised, increased force is applied to the anchor and the reading is captured in the gage. A max memory on the gage is used to retrieve the highest reading before the anchor/asphalt yielded.

It is recommended that a stiff spring be added between the gage and the gage,

to make the reading less critical and jerky. We now use a polyurethane round bar that has been hollowed, to act

as a spring. It is placed between the bar and the fixed jack.
